IMPROVED WINDSHIELD AND CANOPY PROTECTION
DEVELOPMENT PROGRAM

H. EDWARD LITTELL, JR.
PPG INDUSTRIES, INC.
PITTSBURGH, PA. 15238

TECHNICAL REPORT
AFFDL-TR-74-75

JUNE 1974

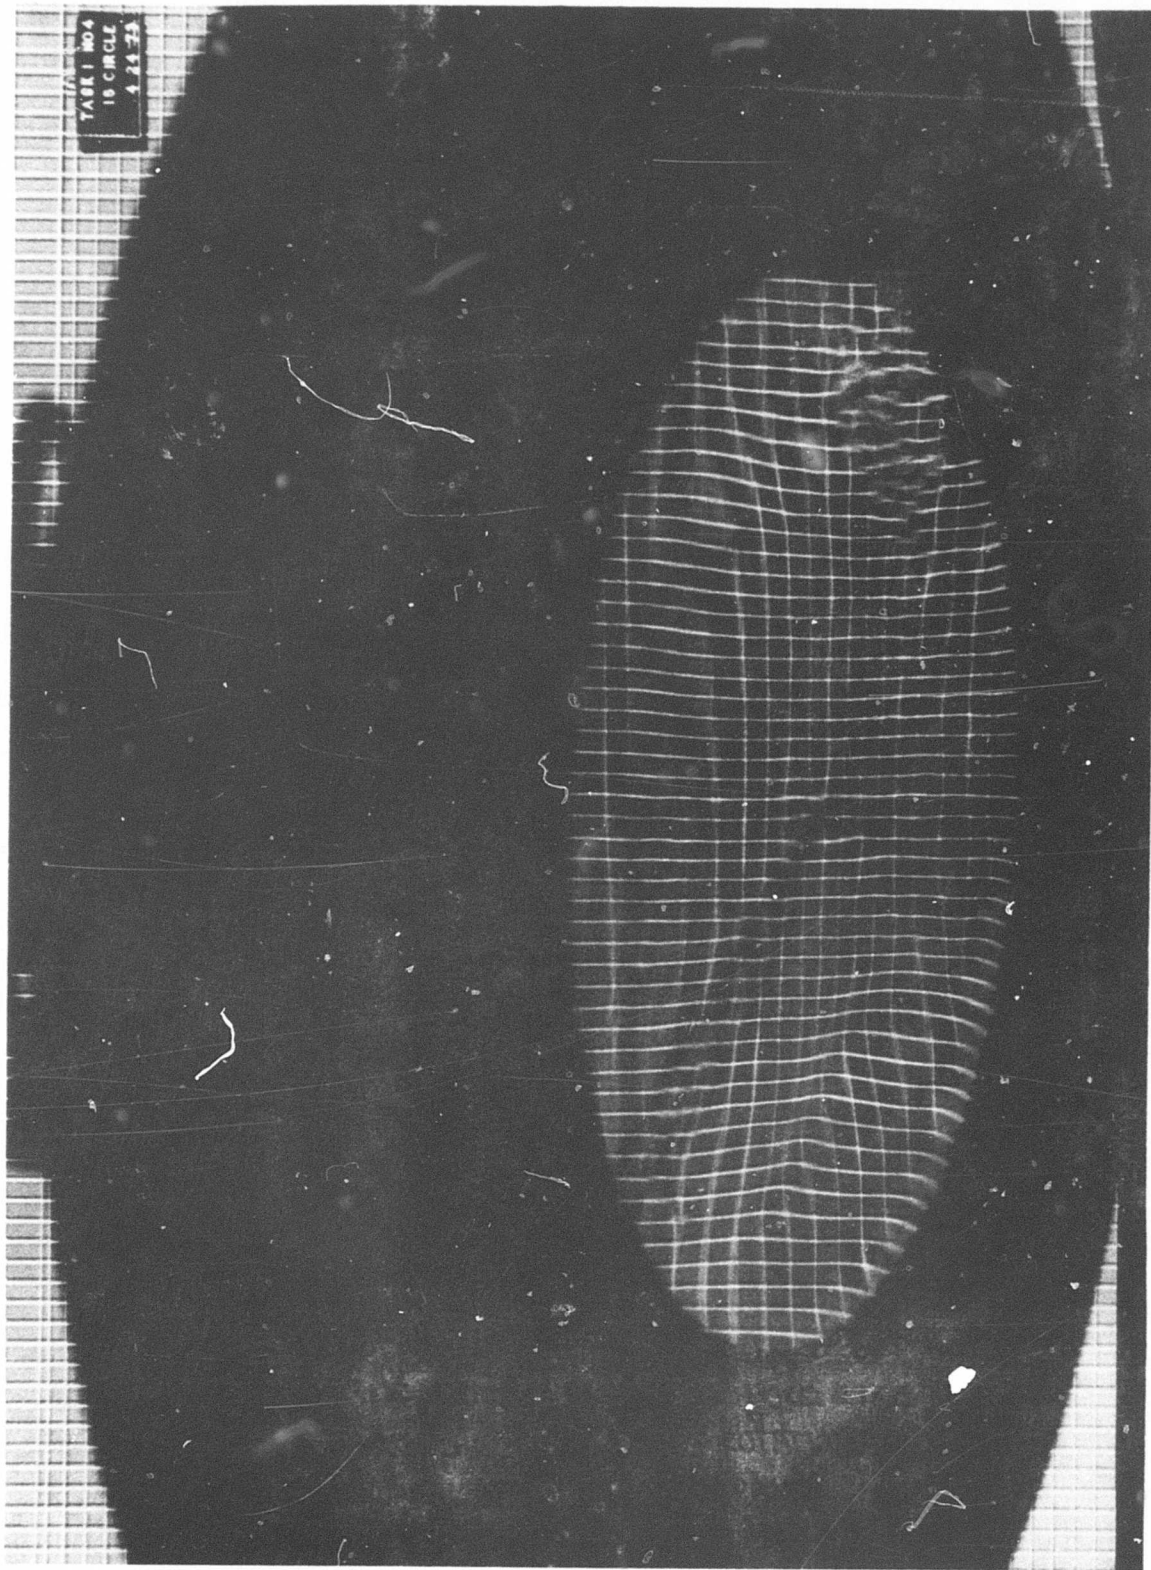
The acrylic-faced panels also showed interlayer bubbles at the higher temperature/pressure exposures comparable to the glass-faced design. Bubbles formed in the interlayer that subsequently helped to cause acrylic deformation. The photographs in Figure 20 show the optical effect of the damage caused by these tests. The photographs present a view of the standard 1" gridboard through panel No. 5 inclined at the F-111 windshield installation angle of 22°. Comparison of the Figure 20(b) photograph with the as-fabricated condition in Figure 20(a) graph illustrates the detrimental effects of the tests.

FIGURE 20(b). THERMAL SAMPLE NO. 5 AFTER TEST

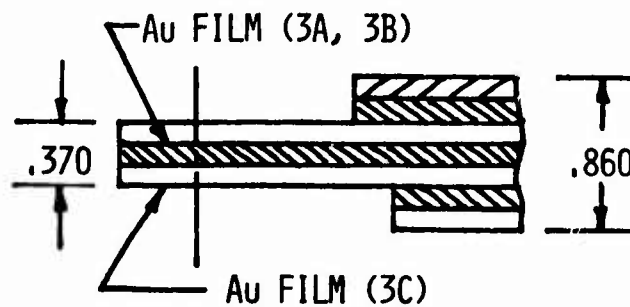
WT-2	3A	FAILED	447 KT	PUNCHED THRU TOP (FRAME)
WT-5	3B	OK	525	NO SHEARING OR PC DAMAGE
WT-7	3C	FAILED	538	SHEARED TOP EDGE

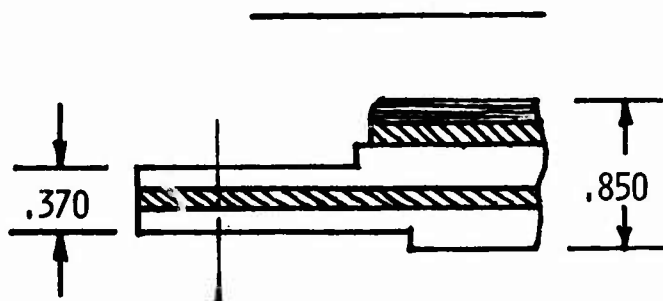
WT-6	8A	FAILED	497 KT	SHEARED AT TOP, CRACKED EDGES
------	----	--------	--------	-------------------------------

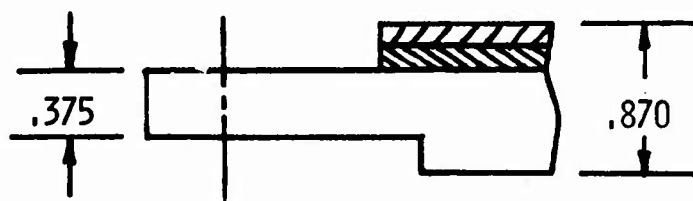
WT-4	5A	FAILED	483 KT	BLEW OUT CENTER
WT-16	5B	FAILED	447	" " "

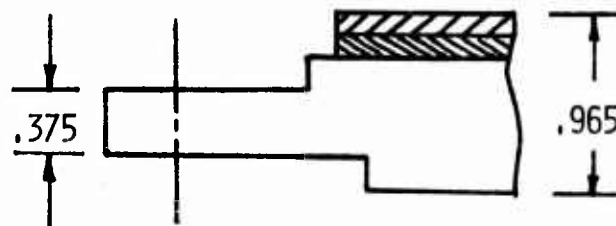
WT-14 6A FAILED 511 KT BLEW OUT CENTER

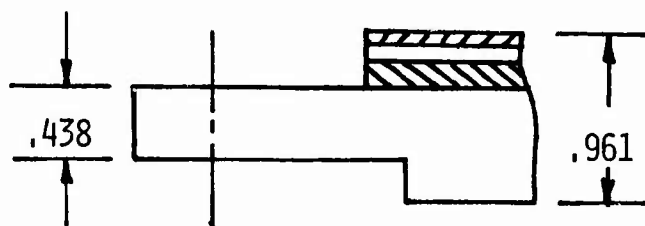
WT-15 14A FAILED 478 KT BLEW OUT CENTER

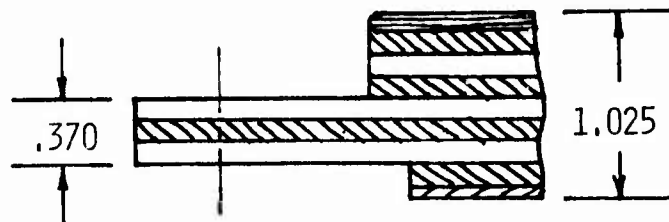
WT-11 9A OK 517 KT PC CRACK AT TOP (CRAZING) PLEX OK

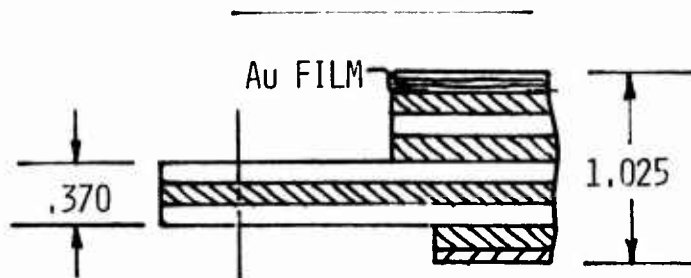
WT-13 10A OK 491 KT PC CRACK AT TOP. GOLD FILM OK. PLEX OK

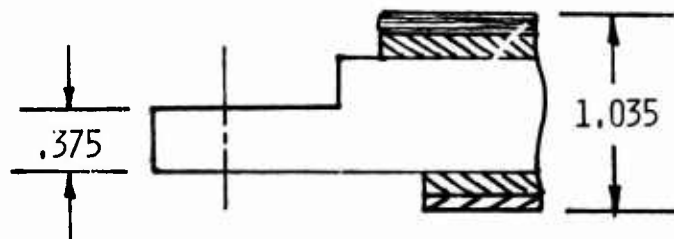
WT-8 11A FAILED 509 KT BLEW OUT CENTER

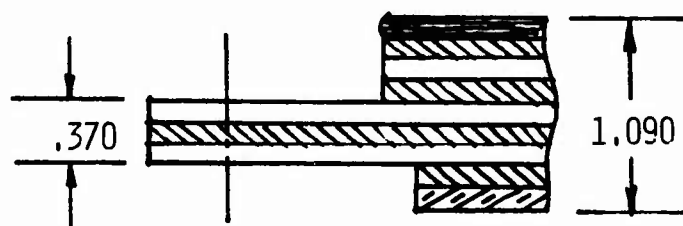
WT-10 12A OK 512 KT PC CRACK AT TOP. DANGEROUS S/A SPALL

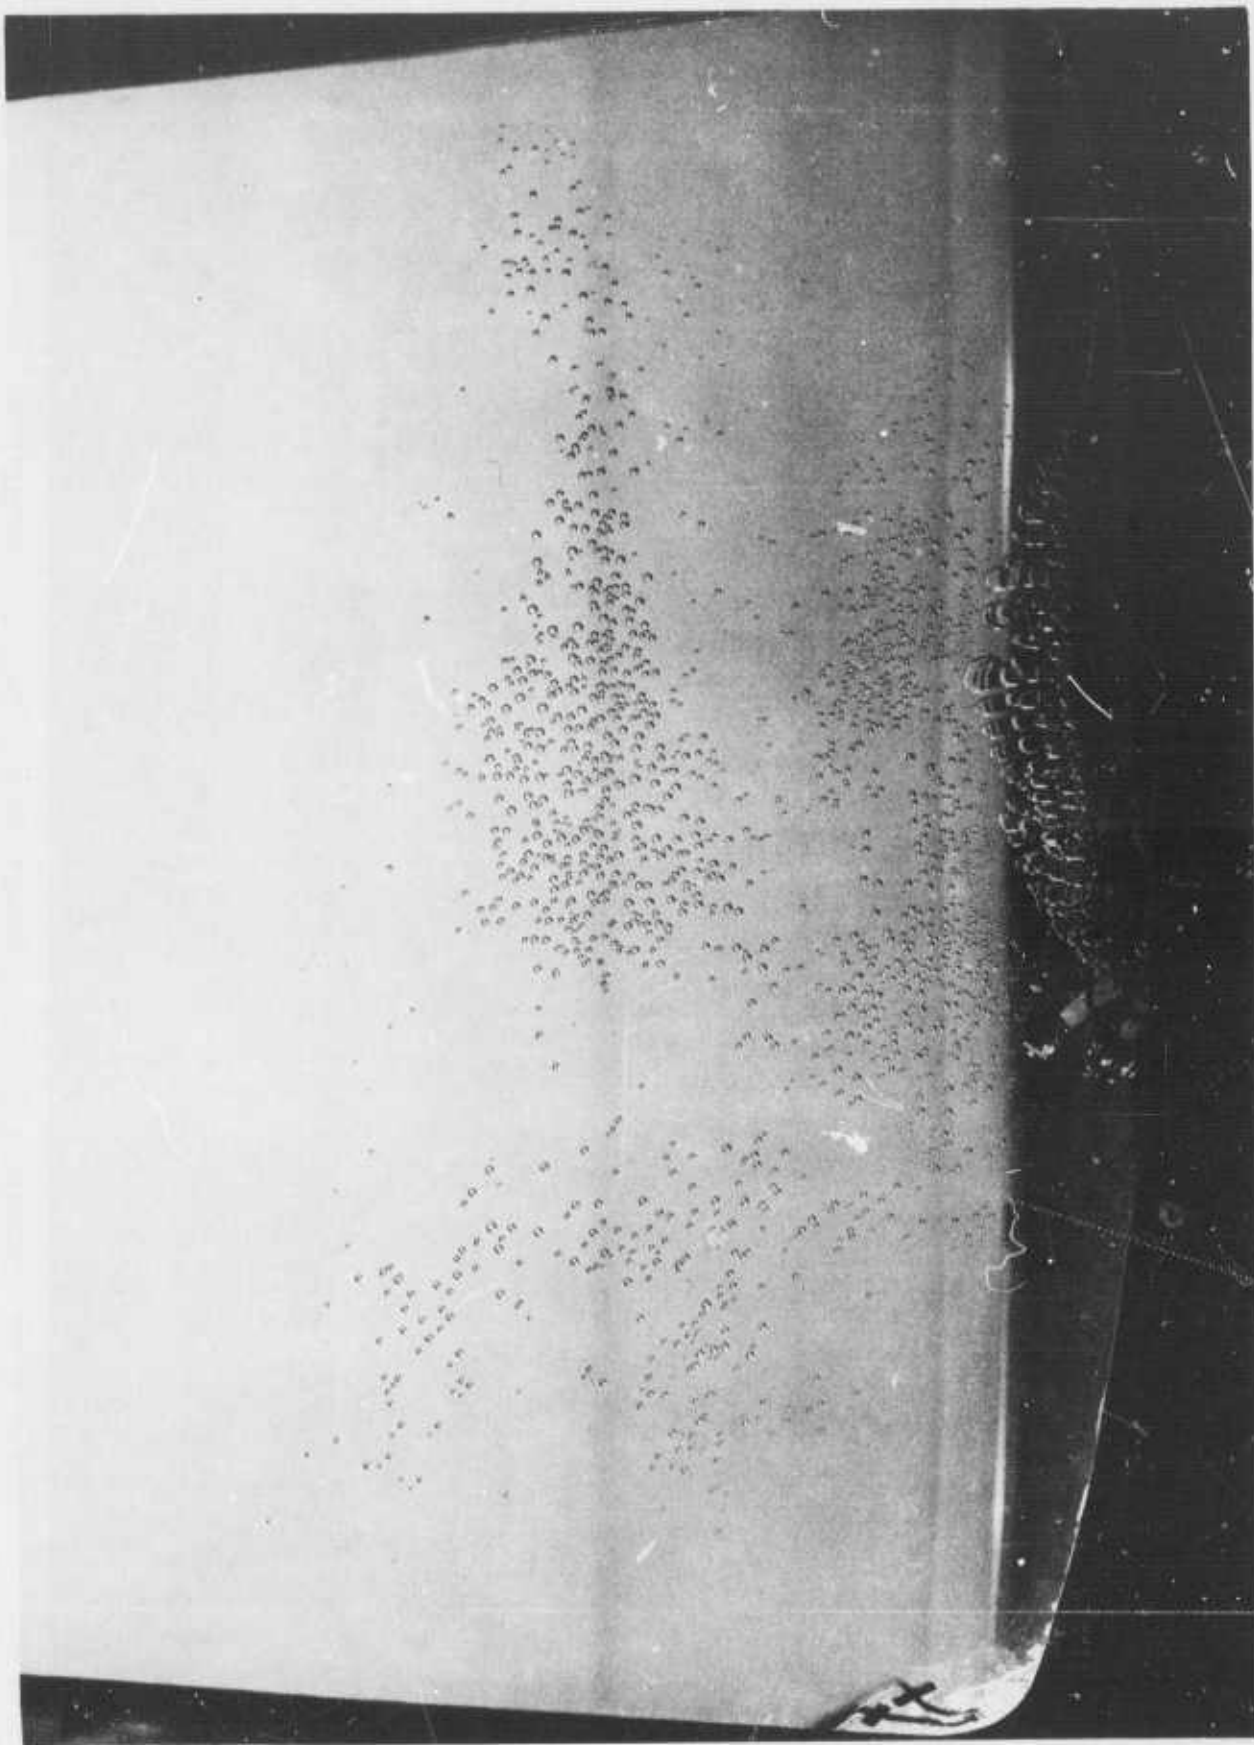
In general, the results indicate that the outermost interlayer cannot withstand the prolonged constant temperature exposure achieved by 360°F outboard with cyclic pressure. This appears to be true for either design. For the acrylic-faced version, interlayer bubbles led to acrylic deformation whereas the glass-faced design problems were delamination and bubbles. However, it must be remembered that these tests were conducted without any cooling of the inboard surface. Therefore, extended exposures approached a steady state condition with a small gradient through the thickness. Since the test set-up did not control the interior cavity at 75°F consistent with the endurance requirement, the actual tests were more severe

FIGURE 38(a). BUBBLES AND DELAMINATION IN GLASS-FACED WINDSHIELD NO. 29
CAUSED BY THERMAL/PRESSURE TEST

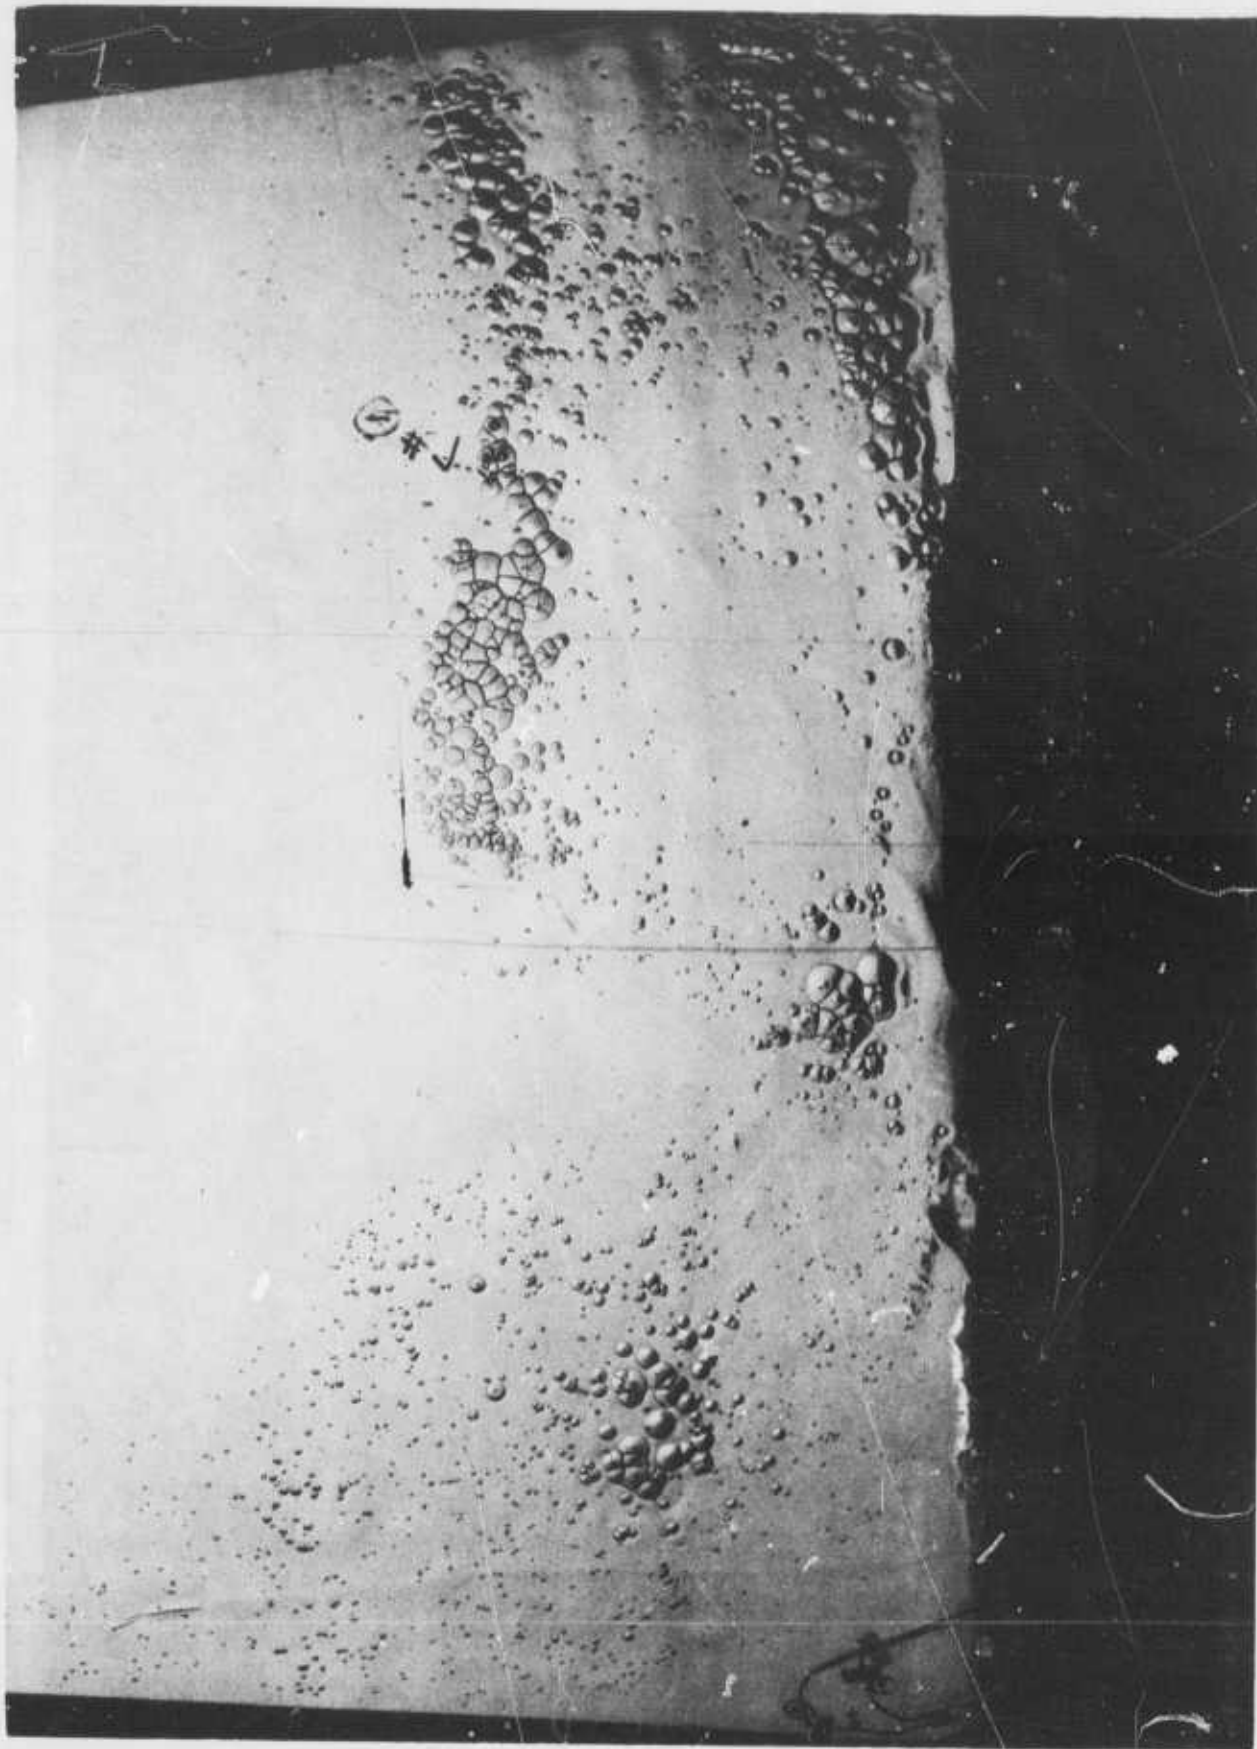
FIGURE 38(b). BUBBLES AND ACRYLIC DAMAGE IN ALL-PLASTIC WINDSHIELD NO. 28
CAUSED BY THERMAL/PRESSURE TEST

than specified. Although this was the case, it is felt that neither design would successfully pass the specified one life-time test, especially with the optics requirement. In this test, the glass-plastic candidate was better than the all-plastic with a .185" outer combination of .060" acrylic and 1/8" PC. For an all-plastic design, a fused ply of .060" acrylic and 3/16" PC would be required.

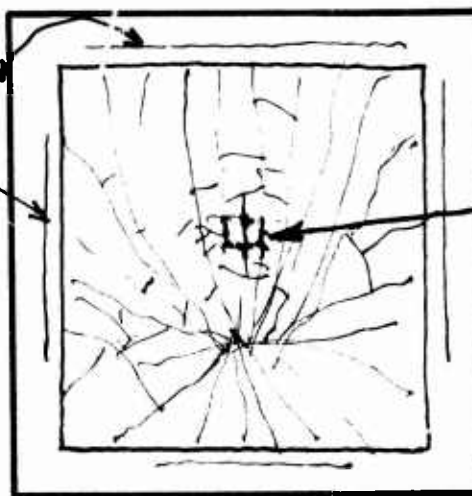
SLIGHT
NECKING
OF IIZ &
DELAM.
AT PLEX
CRACKS
IN MAX.
BULGE

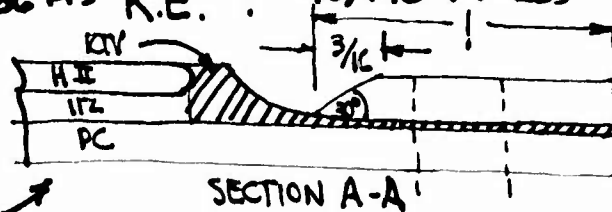
BIRD DID NOT PENETRATE. PORTION
OF TOP EDGE RETAINER REMOVED
LEAVING MODIFIED 1" RETAINER SHOWN

NO RETAINER PEELING AND ONLY SLIGHT SEPARATION FROM RTV IN 2 PLACES. 8 BOLTS OFF ALONG TOP EDGE (SHEARED @ 1ST THREAD)

SPALL. INBOARD SPALL PERFORATED FOIL OVER FORM PLACED VERTICALLY BEHIND PANEL & HORIZONTALLY BELOW (40") PANEL. PARTICLES STUCK IN BOTH W/P'S. LARGEST PARTICLE: .060" x .188" x .750".

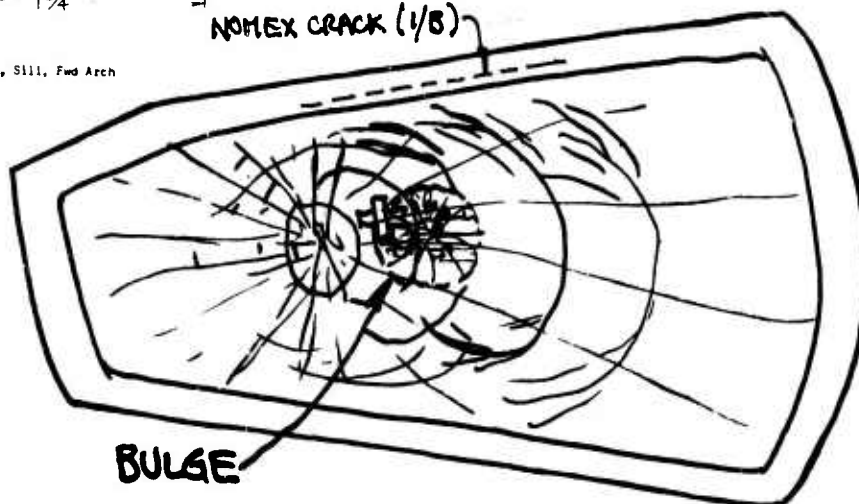
NOMEX CRACK (1/8")

SAME IMPACT POINT
AS WT-39.

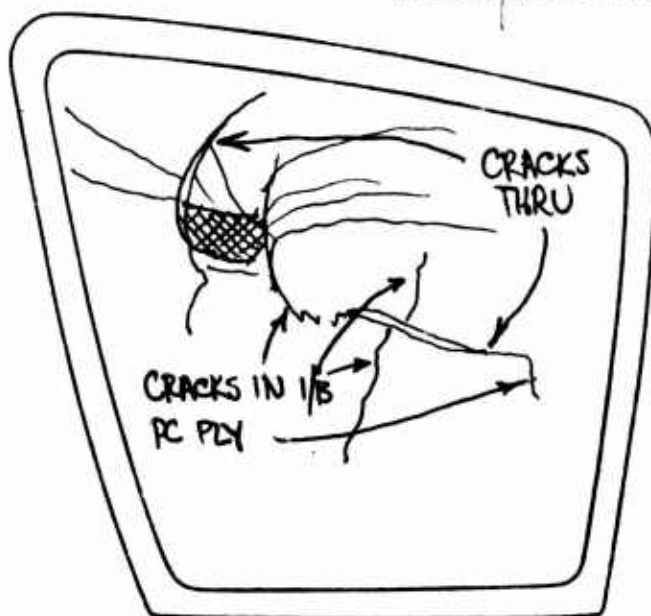
CRACKS THRU
